Lion-Beer, Spirits & Wine Pty Ltd
Level 7, 68 York Street
Sydney NSW 2000

Project 71021.19
22 June 2023
R.001.Rev0
KDP:jl

May 2023 Groundwater Monitoring
Tooheys Brewery
29 Nyrang Street, Lidcombe

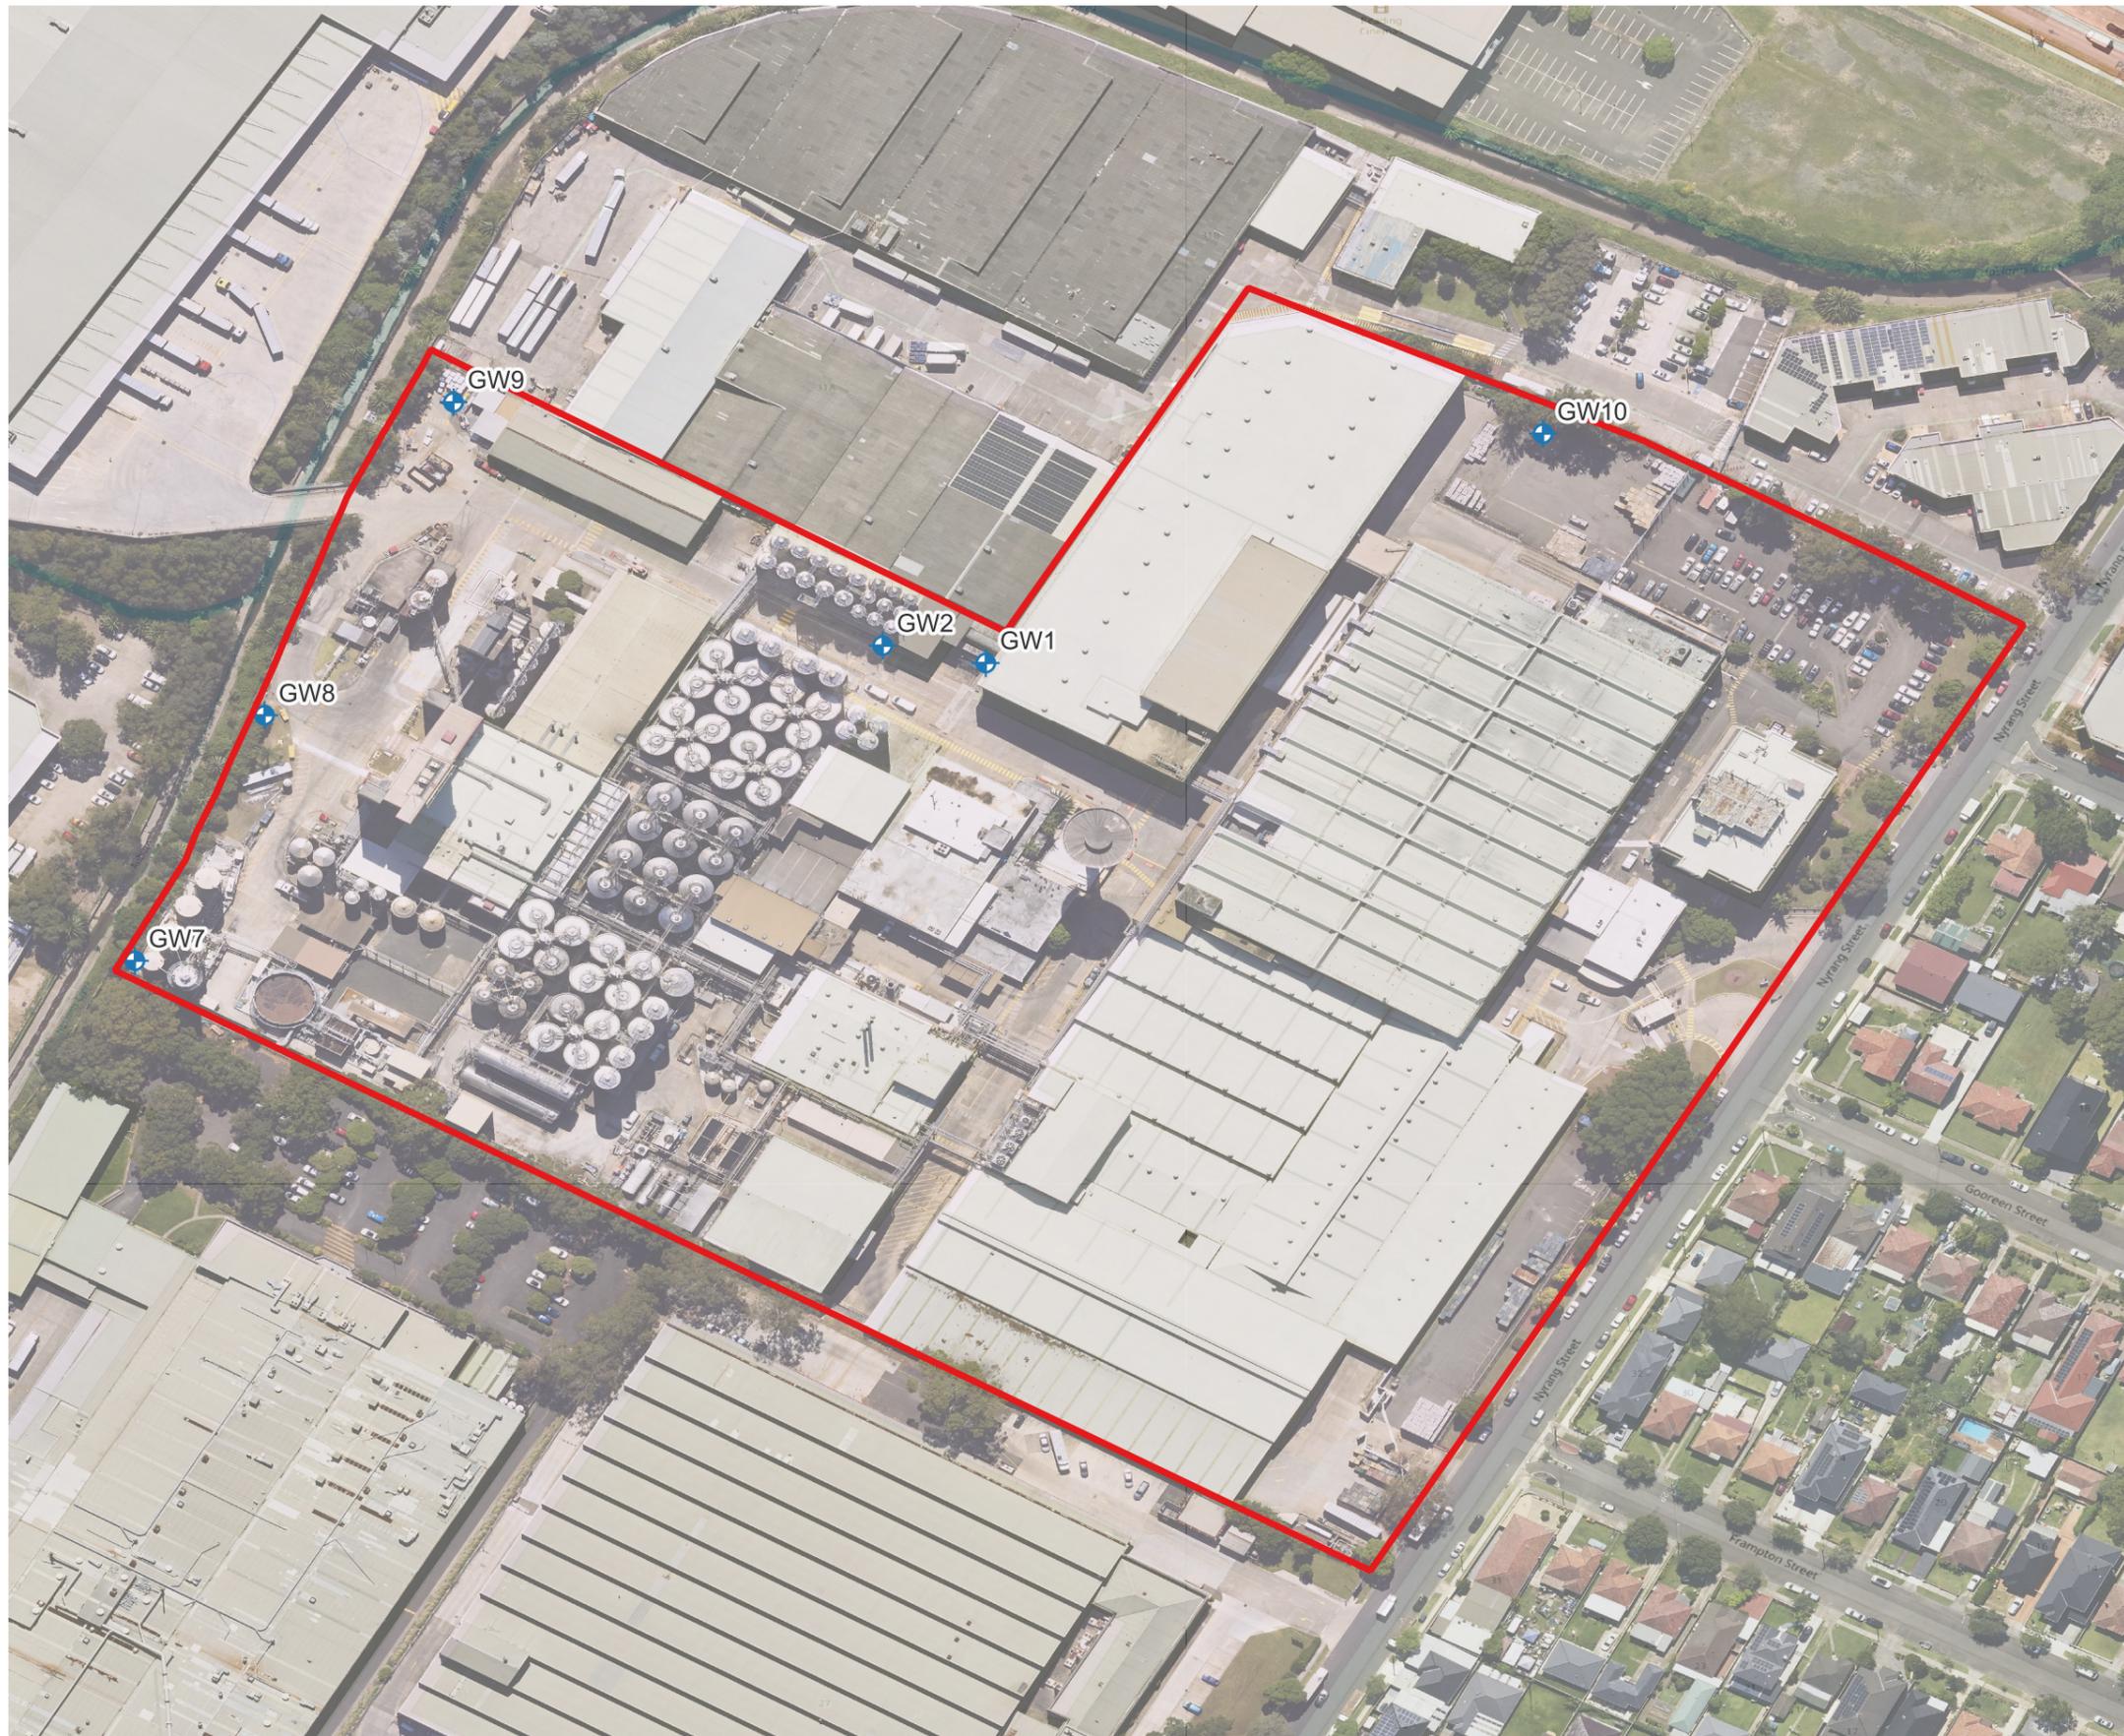
The site is used for the production and storage of Tooheys' beer, which is transported and distributed by trucks to various outlets. The majority of the site is occupied by large warehouse structures and large fermentation, maturation and storage tanks/silos. A site drawing and borehole location plan are presented in Drawing 1, attached.

The locations of the six existing wells labelled BH1, BH2, BH7, BH8, BH9 and BH10 along the western and northern boundaries of the site are presented in the attached Drawing 1.
