Project 71021.17
13 December 2021
R.002.Rev0
KDP:jl

November 2021 Groundwater Monitoring
Tooheys Brewery
29 Nyrang Street, Lidcombe

This letter report by Douglas Partners Pty Ltd (DP) provides the laboratory results and a brief discussion of the November 2021 round of Groundwater Monitoring at the Tooheys Brewery Site at 29 Nyrang Street, Lidcombe.

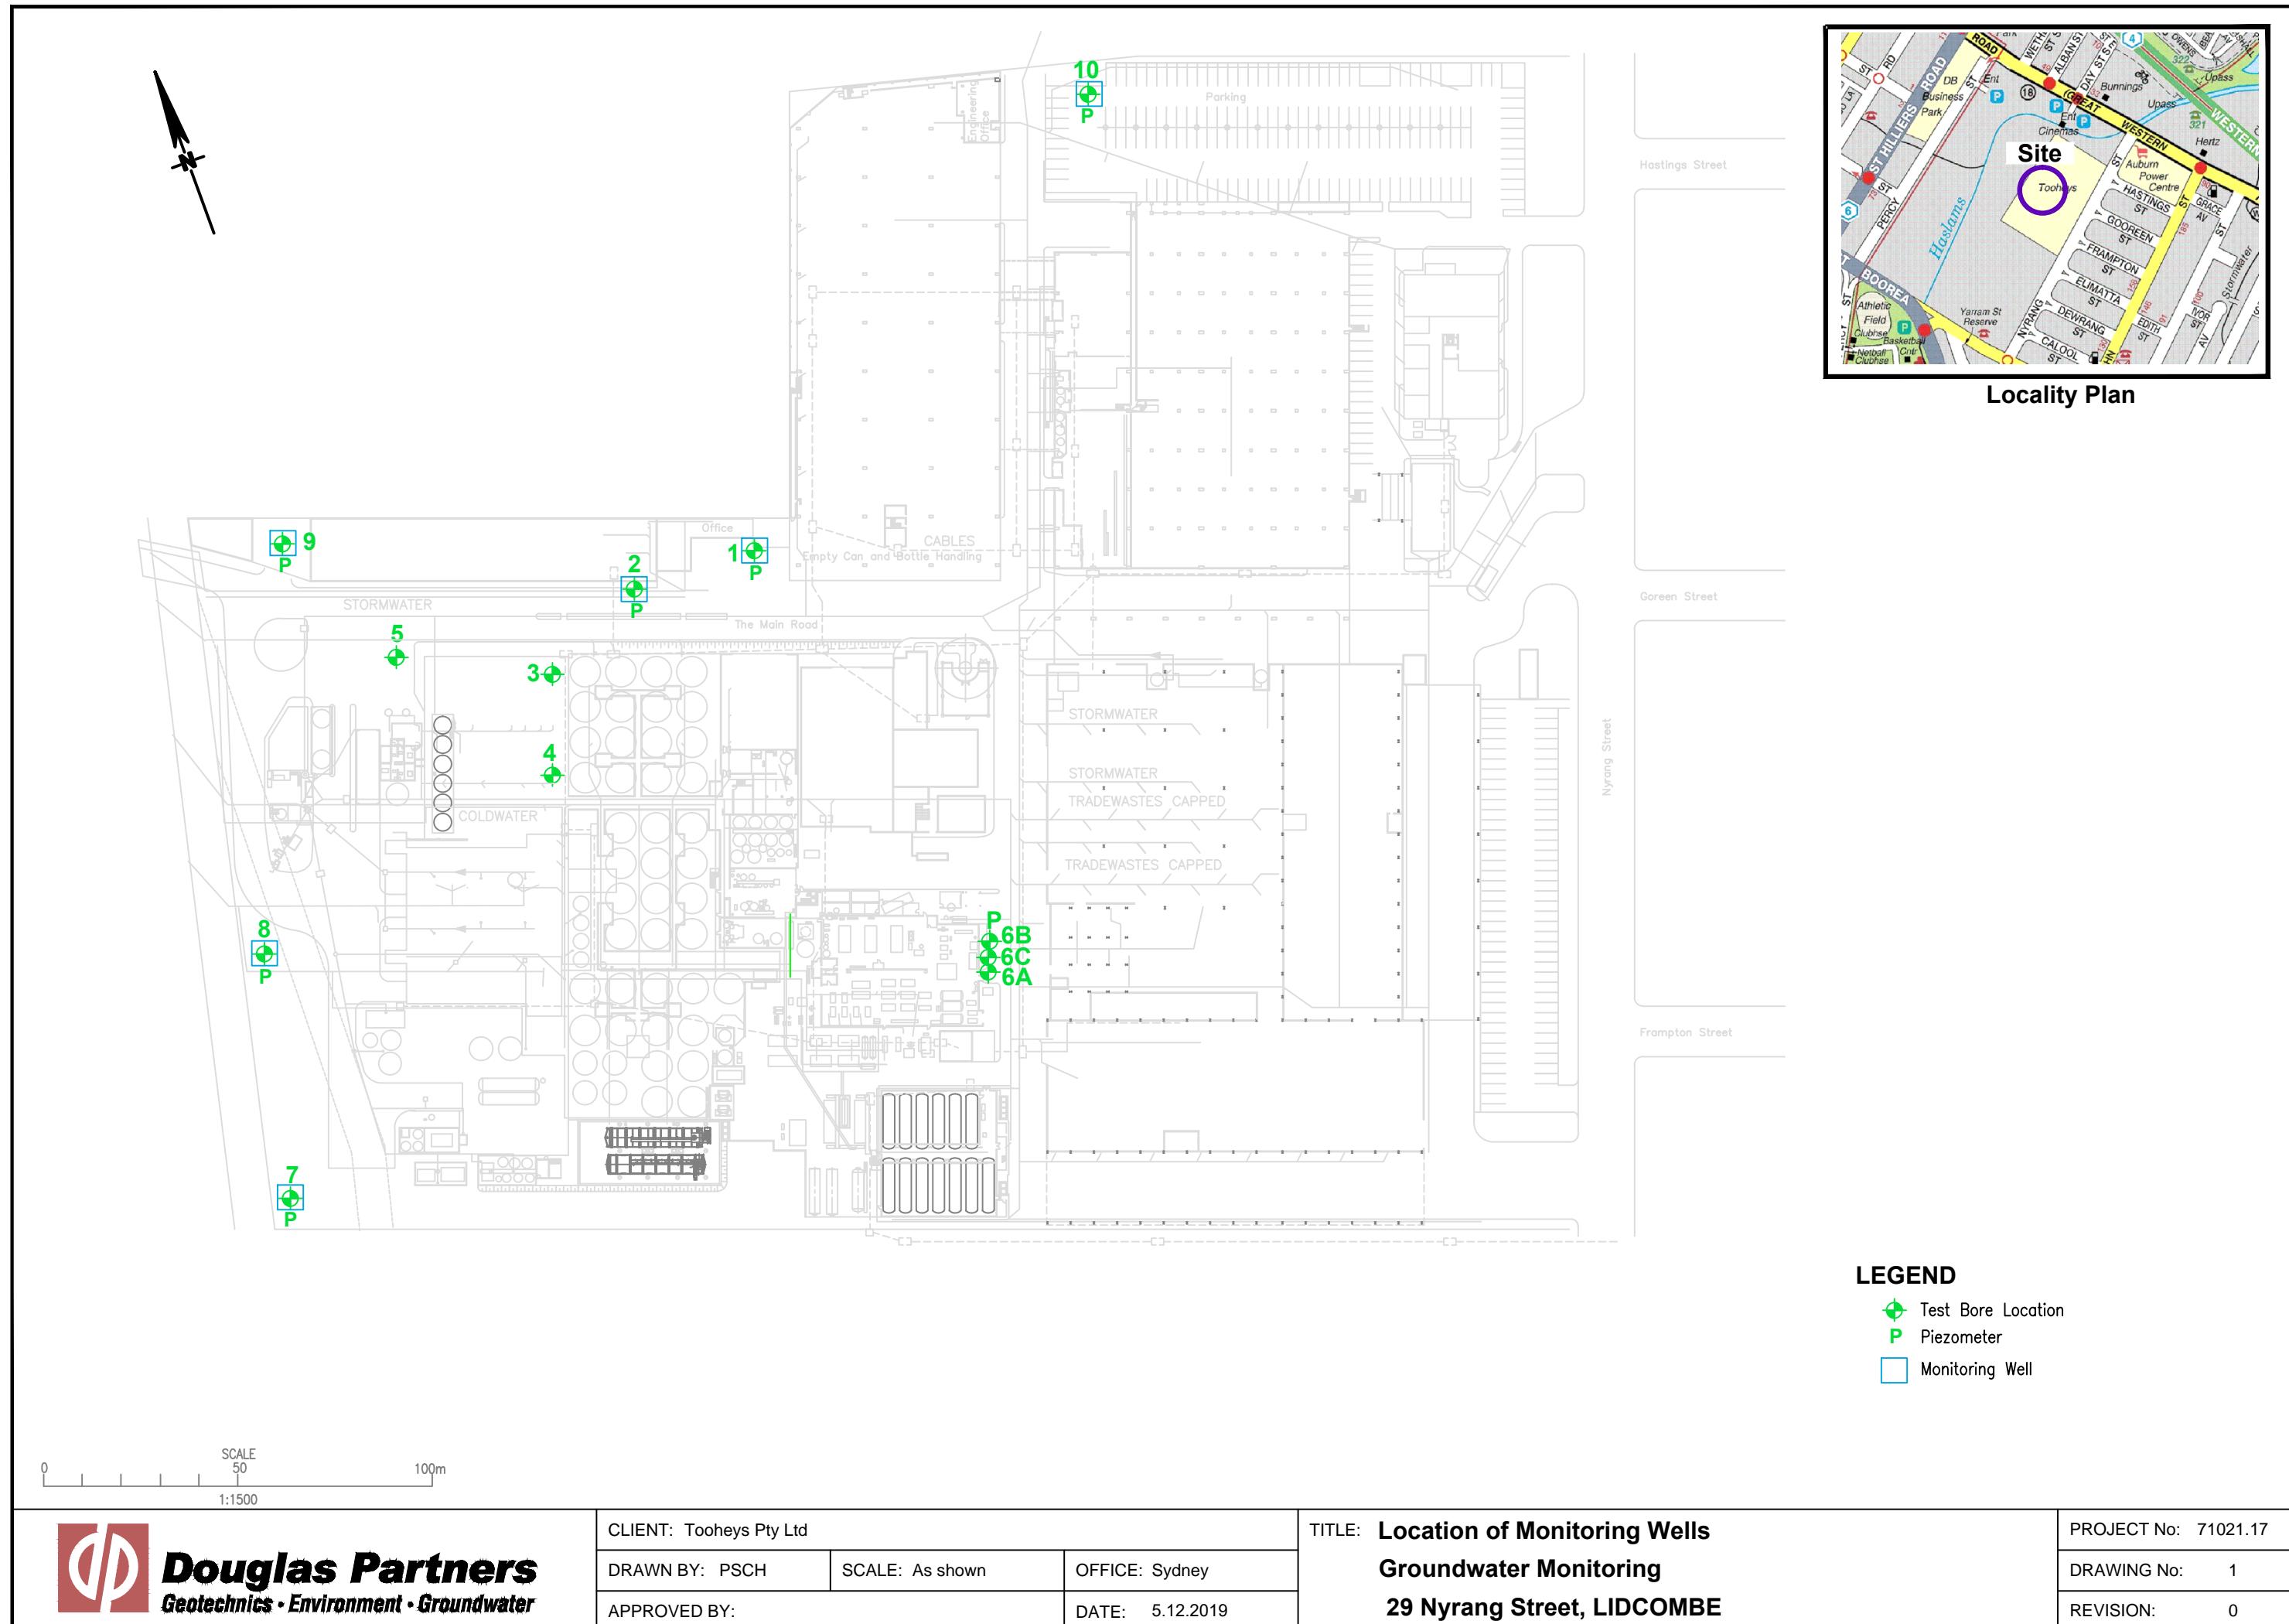
The site is used for the production and storage of Tooheys' beer, which is transported and distributed by trucks to various outlets. The majority of the site is occupied by large warehouse structures and large fermentation, maturation and storage tanks/silos. A site drawing and borehole location plan are presented in Drawing 1, attached.

The locations of the six existing wells labelled BH1, BH2, BH7, BH8, BH9 and BH10 along the western and northern boundaries of the site are presented in the attached Drawing 1.
